New Generation Features
Rubber Tracks for Excavators

Bridgestone, Rubber Track Experts

New Features

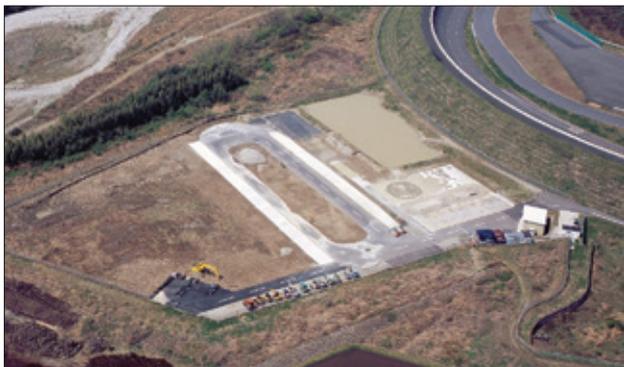
Bridgestone Proving Ground

Bridgestone's state-of-the-art Rubber Track proving ground, located in Tochigi-Japan, ensures the highest integrity designs for Rubber Tracks and undercarriage systems. A variety of terrain conditions are maintained in order to establish consistency during the testing process.

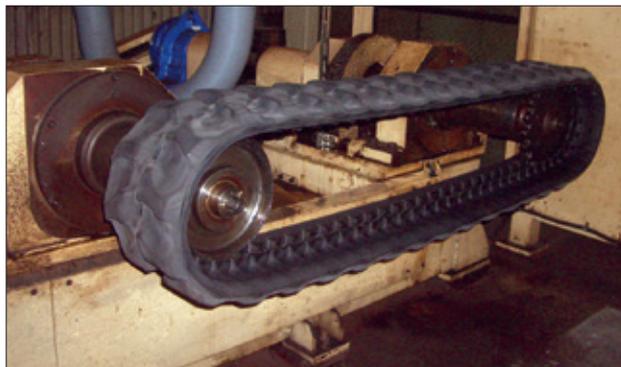
Laboratory Bench Testing

Laboratory bench testing is vital to accelerate evaluation under controlled conditions. All Bridgestone Rubber Tracks are tested, evaluated, and proved.

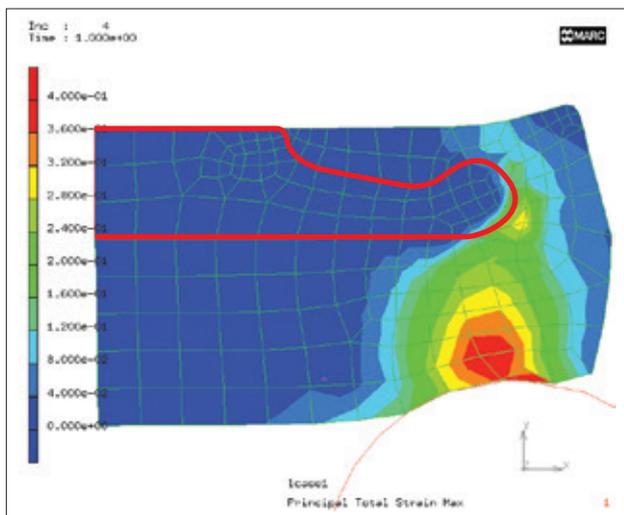
FEM Analysis System

Bridgestone's scientifically proven non-linear, large-displacement FEM analysis system helps engineers to create innovative technologies.

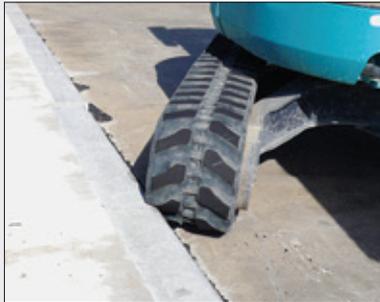
Common cause of edge-cut

Edge-cut is a common type of damage for tracks used on construction sites. When a machine drives against a curb, stump or sharp/solid object, the edge of the track can bend over, shearing the rubber between the edge of the track and the tip of the embedded core metal.

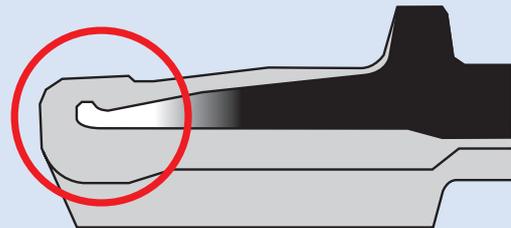
Bridgestone developed innovative Pro-Edge technology to minimize edge-cut damage. Pro-Edge technology is based on the combination of a rounded shape core metal edge design to avoid the build-up of stress concentrations, and additional rubber volume on both the inner and tread sides to make the track edge more durable.

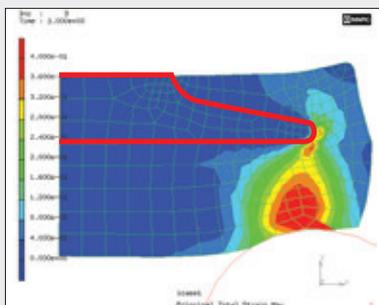
Standard core metal

47% less stress on the core metal edge compared to a standard core metal.

Bridgestone's Pro-Edge technology is now well accepted by many customers and proved in the market. The benefits of Pro-Edge are also proved by Bridgestone's internal testing and by FEM analysis.

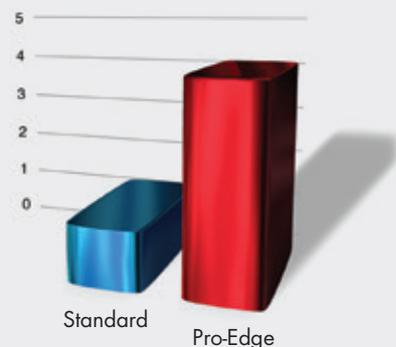
Pro-Edge 4-fold improvement

300mm width track testing data on 3.5ton machine. Graph shows the number of trials made before edge cut occurred.

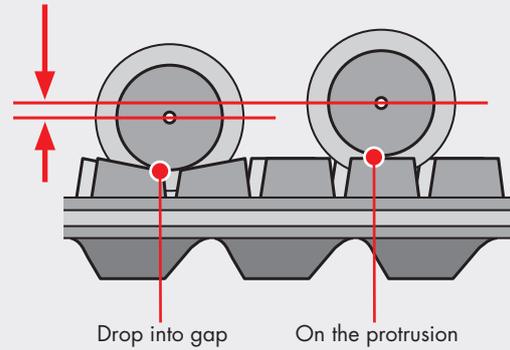
Track roller vertical movement

Good ride comfort is of vital importance to the health and safety of machine operators. Low vibration is a key factor considered when selecting a machine and a rubber track. Some vibration is caused by the vertical movement of track rollers when dropping into the gaps between each core metal protrusion.

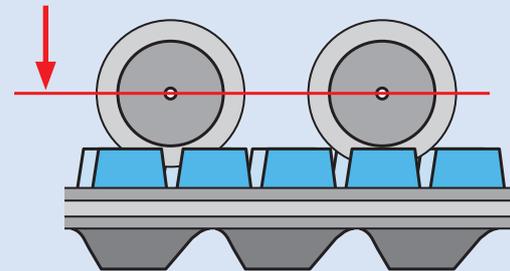
Reduced track roller vertical movement

Bridgestone has reduced the vertical movement of the track rollers by adopting an advanced tapered protrusion technology. The tapered shape of the running surface of the protrusion optimizes the roller path against the natural rotation of the core metal under vertical load. This results in good ride comfort without the need of additional material. Avoiding the use of additional material is in line with Bridgestone's environmental policy.

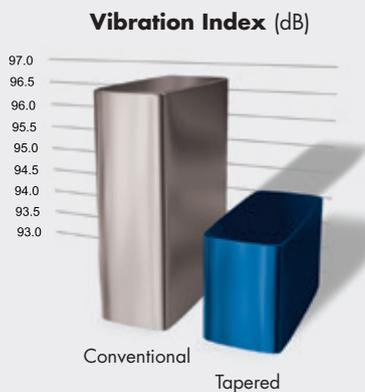
FEM analysis result: Track roller vertical movement

Data obtained by FEM analysis and field testing clearly shows a reduction in vibration using tapered core metals. This brings greater ride comfort to the operator.

Testing carried out at Bridgestone's proving ground in Tochigi Japan using 5.3ton machine on asphalt.

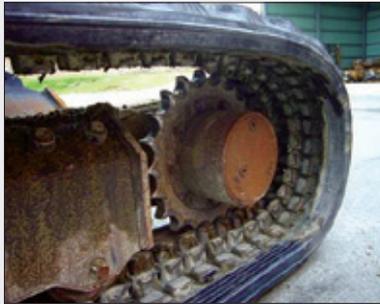
De-tracking at sprocket

De-tracking is when a track partially removes itself from the undercarriage during operations by disengaging from one of the components such as the sprocket, idler or rollers. This causes down-time and can lead to failure by fatal breakage.

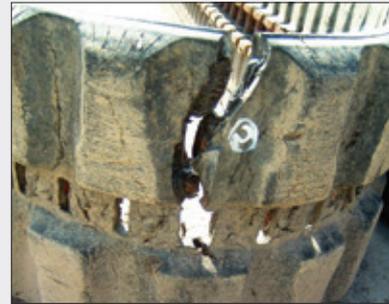
Steel cord breakage caused by de-tracking

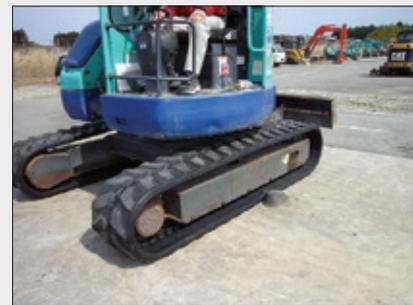
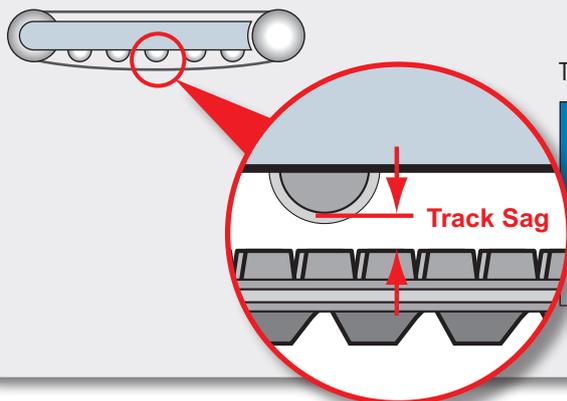
The following testing was carried out at Bridgestone's proving ground in Tochigi Japan. Even in loose tension conditions (sag=45mm) interlocking tracks did not de-track.

Test data from 5.3ton machine, 10 trials against fixed rock.

Tension	Track sag	De-tracking occurrence	
		Interlocking	Non-Interlocking
Normal	15mm	Zero	6
Loose	30mm	Zero	10
Very Loose	45mm	Zero	10

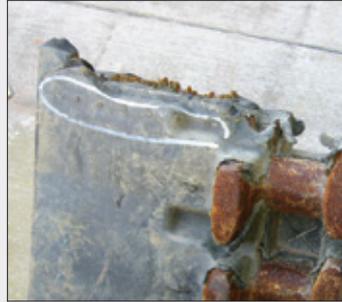
The majority of Rubber Tracks utilize a traditional overlap type structure of steel cord. When the track is under abnormal stress such as excessive tension, failure often occurs at the ends of the overlap area. This is expected due to the inferior uniformity in the circumferential steel cord structure.

Steel cord breakage at end of overlap

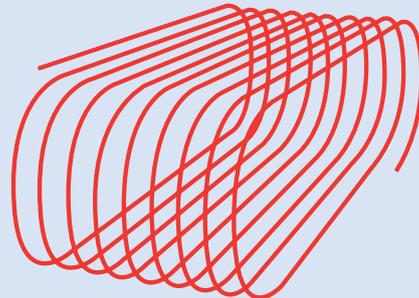
Spiral structure

Bridgestone has developed a spiral steel cord structure which is now a technology commonly used in Bridgestone tracks used on Compact Track Loaders. This technology is now being expanded into excavator tracks. Spiral steel cord technology offers complete uniformity of tensile strength around the circumference of the track. In addition to even tension, an even distribution of traction minimizes the risk of track breakage.

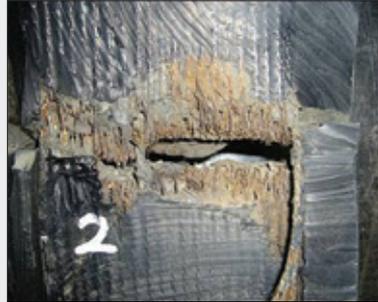
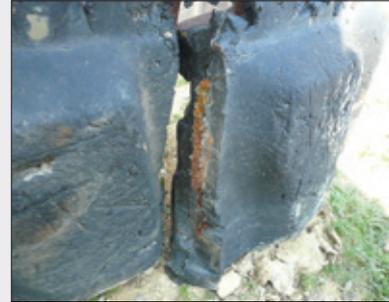
Once deep external cuts, chunking and edge cut have occurred, the danger of water and mud penetrating the rubber track is greatly increased. Moisture attacks the embedded steel cord. Depending on the severity of the damage and working conditions, the tensile strength of rusted steel cords weakens and can lead to breakage.

Steel cord deterioration caused by rust

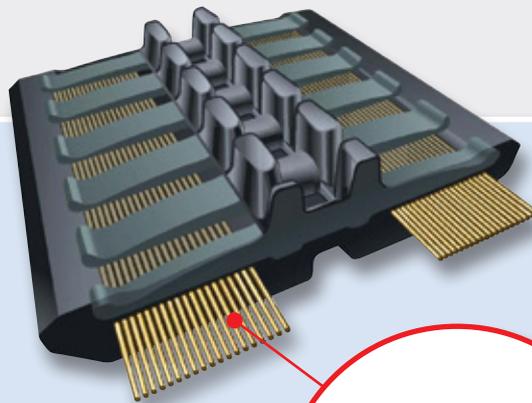
Thanks to Bridgestone's world leading tire technology, our engineers have developed an advanced Anti-Rust Steel cord which minimizes deterioration caused by rust.

Even when moisture/mud penetrates from external cuts, steel cord tensile strength is maintained for longer.

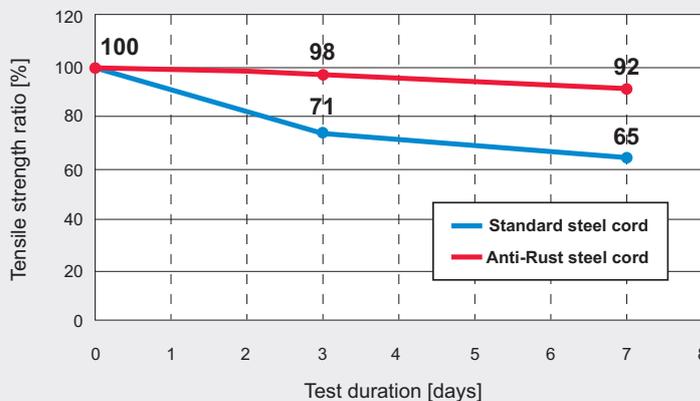
Anti-Rust Steel cord deterioration performance

Salt bath testing carried out over 7 days has proved over 41% improvement in performance compared with standard steel cord.

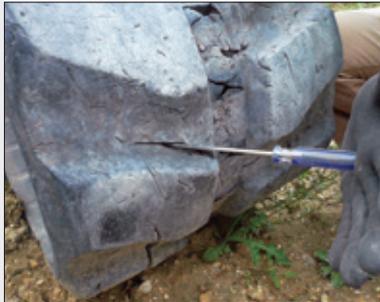
External cut

Harsh working conditions are normal for excavator operations. Such conditions cause external cuts and chunking to the tread rubber. Moisture and mud can penetrate from external cuts, causing internal steel parts to progressively weaken. This can lead to fatal failure such as steel cord breakage.

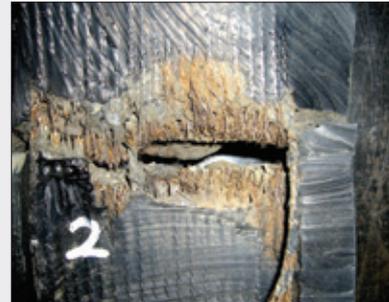
Steel cord breakage caused by rust

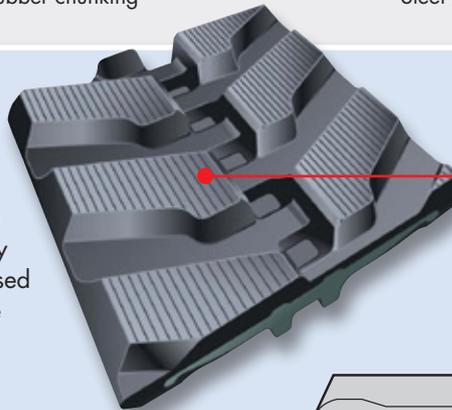
Tread side is made of an Anti-Cut Rubber compound.

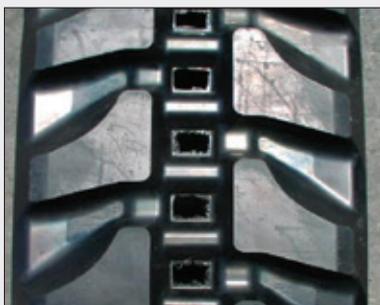
Before testing

Test data shows reduced occurrences of cut damage and chunking. The photos below compare the track condition after 140hrs of continuous tracking using a 3.5ton machine at Bridgestone's proving ground.

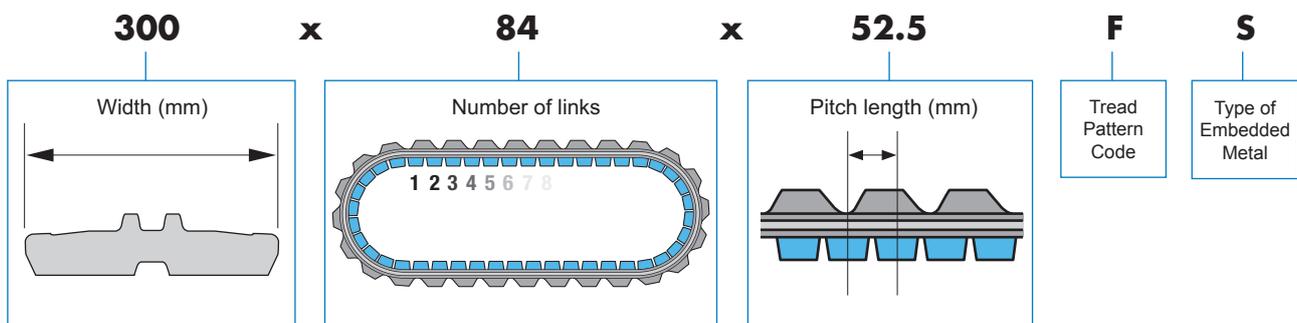
Track size indication

Track size is indicated by a size numbering system consisting of 5 elements. This part number is normally vulcanized on the inner surface of the track.
